# Trinity River Authority Clean Rivers Program 2011 Basin Update Report

## Existing Conditions Survey

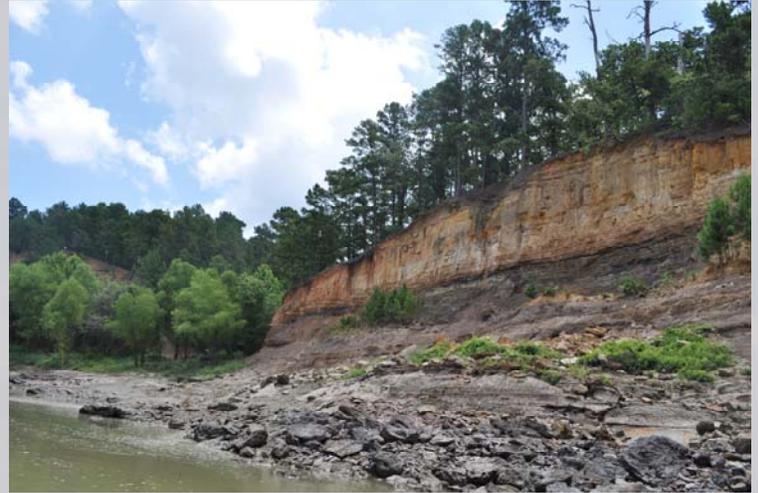
The Middle Trinity River is generally homogenous throughout most of the 105 mile reach, excluding three distinct portions of the river: Yard, Pine Bluff, and Hurricane Shoals. Overall, the Middle Trinity is highly sinuous with steep, high banks that get more so moving downstream. Generally, the banks are sand, silt, and clay with sand becoming more common further downstream. The river follows the riffle, run, pool pattern, though there are sometimes long distances between riffles. Straight runs have depositional banks with a mixture of

Pine Bluff, July 2010.

bare soil and willow trees near the water's edge. Bends generally follow the common cut bank and point bar deposition pattern. Depths near base flows in runs are generally 5-8 ft, riffles 2-4 ft, and deep pools in bends 17-20 ft. A few pools near the lower end of the reach have depths > 25 ft. Evidence of recent and past mass failures/slumps is abundant. Large snags of timber are common and create a significant navigation hazard.
